Regarding Solar System EVA 55

I have been monitoring my solar system regularly ever since I have moved into EVA 55.

With the rainy season now happening and more moisture in the air and more cloud cover and less UV radiation or direct sun there seems to be an issue with my solar installation.

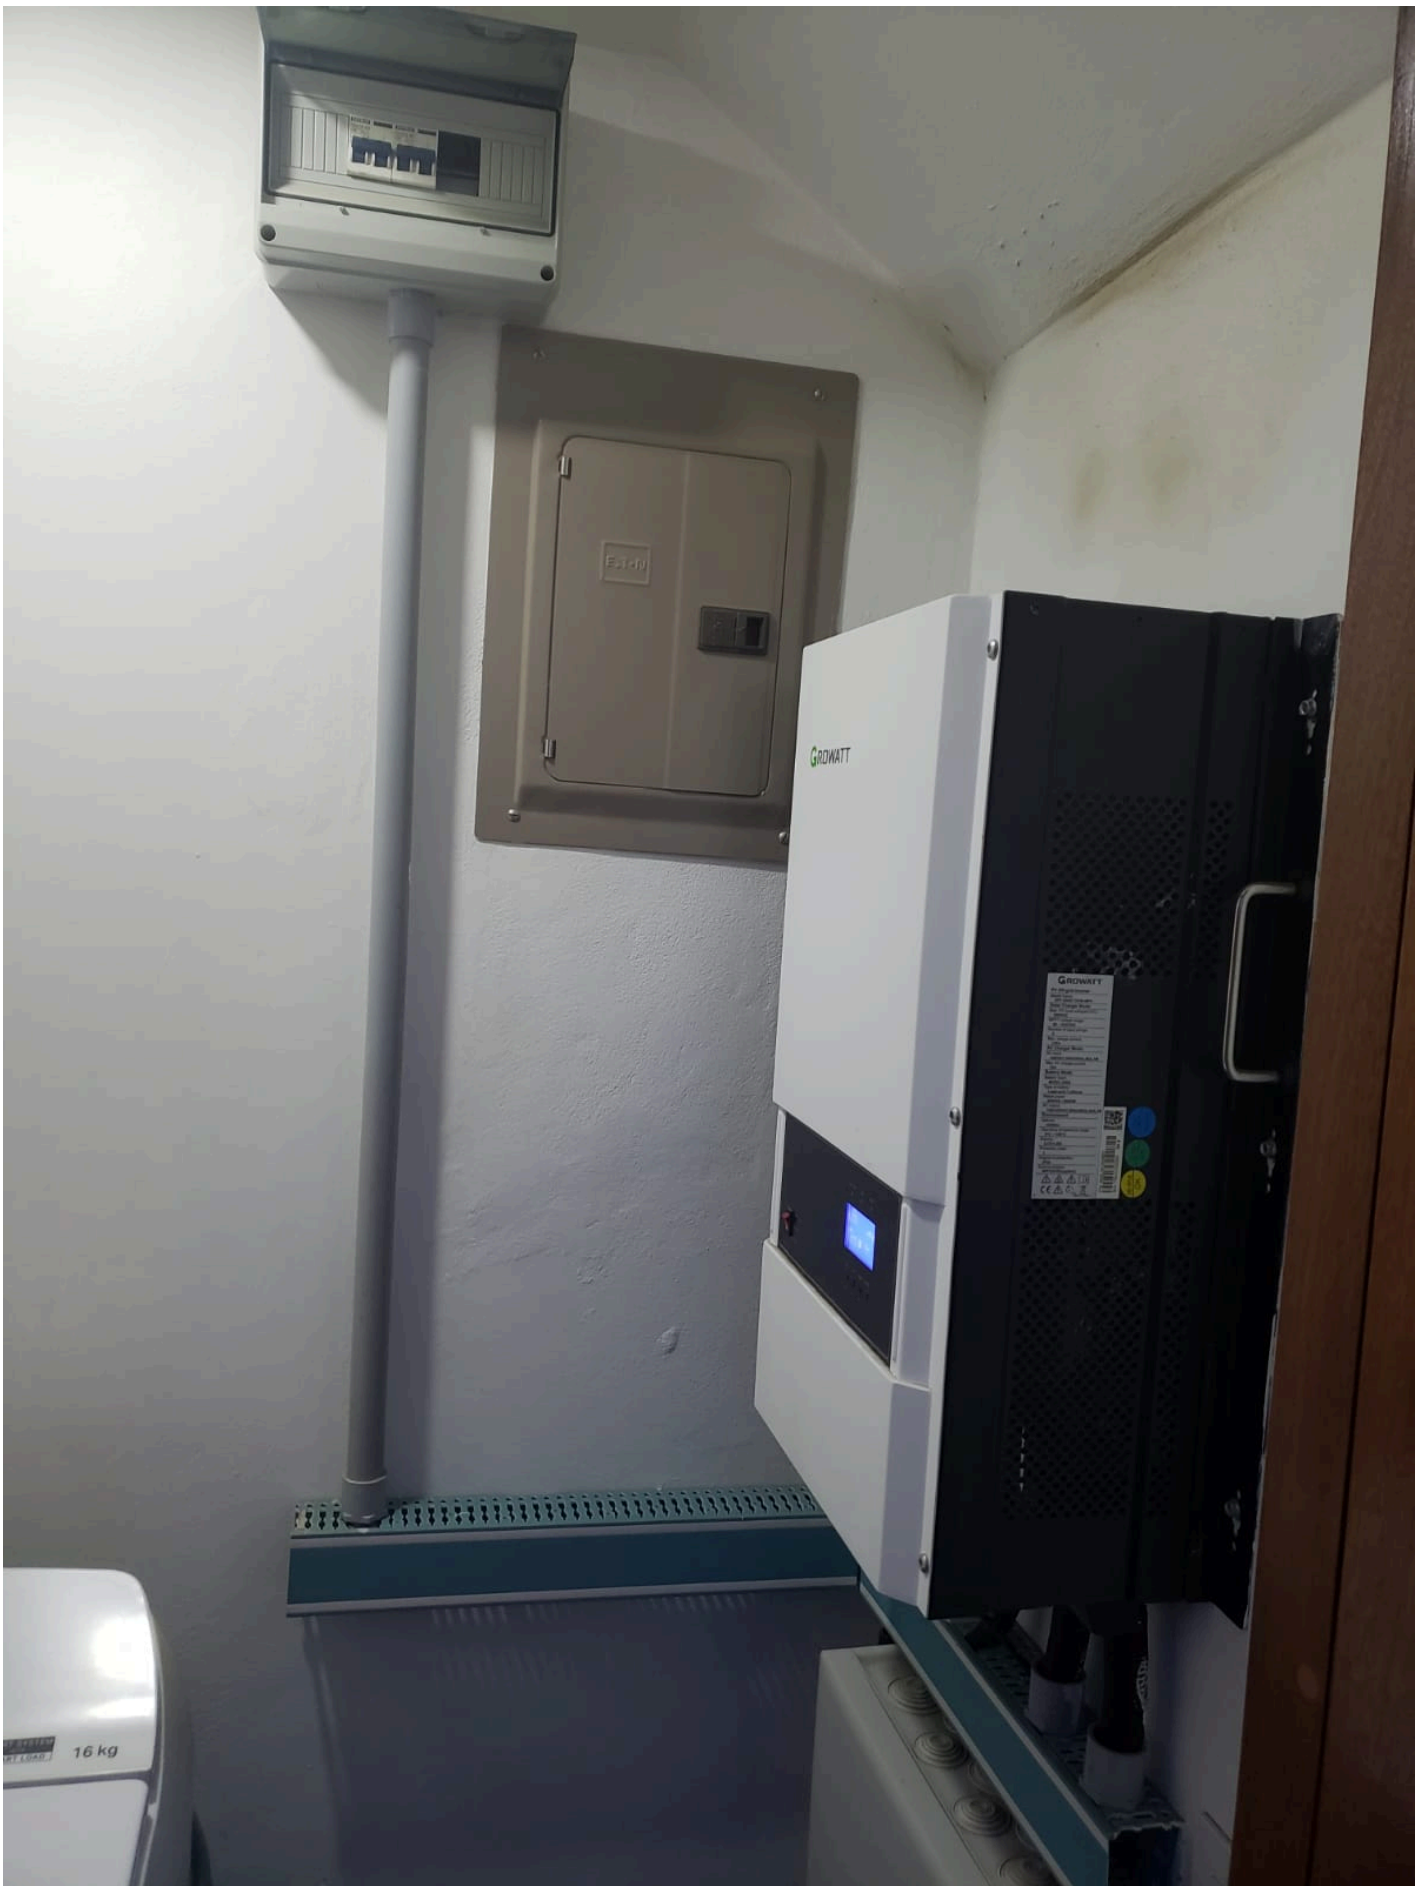
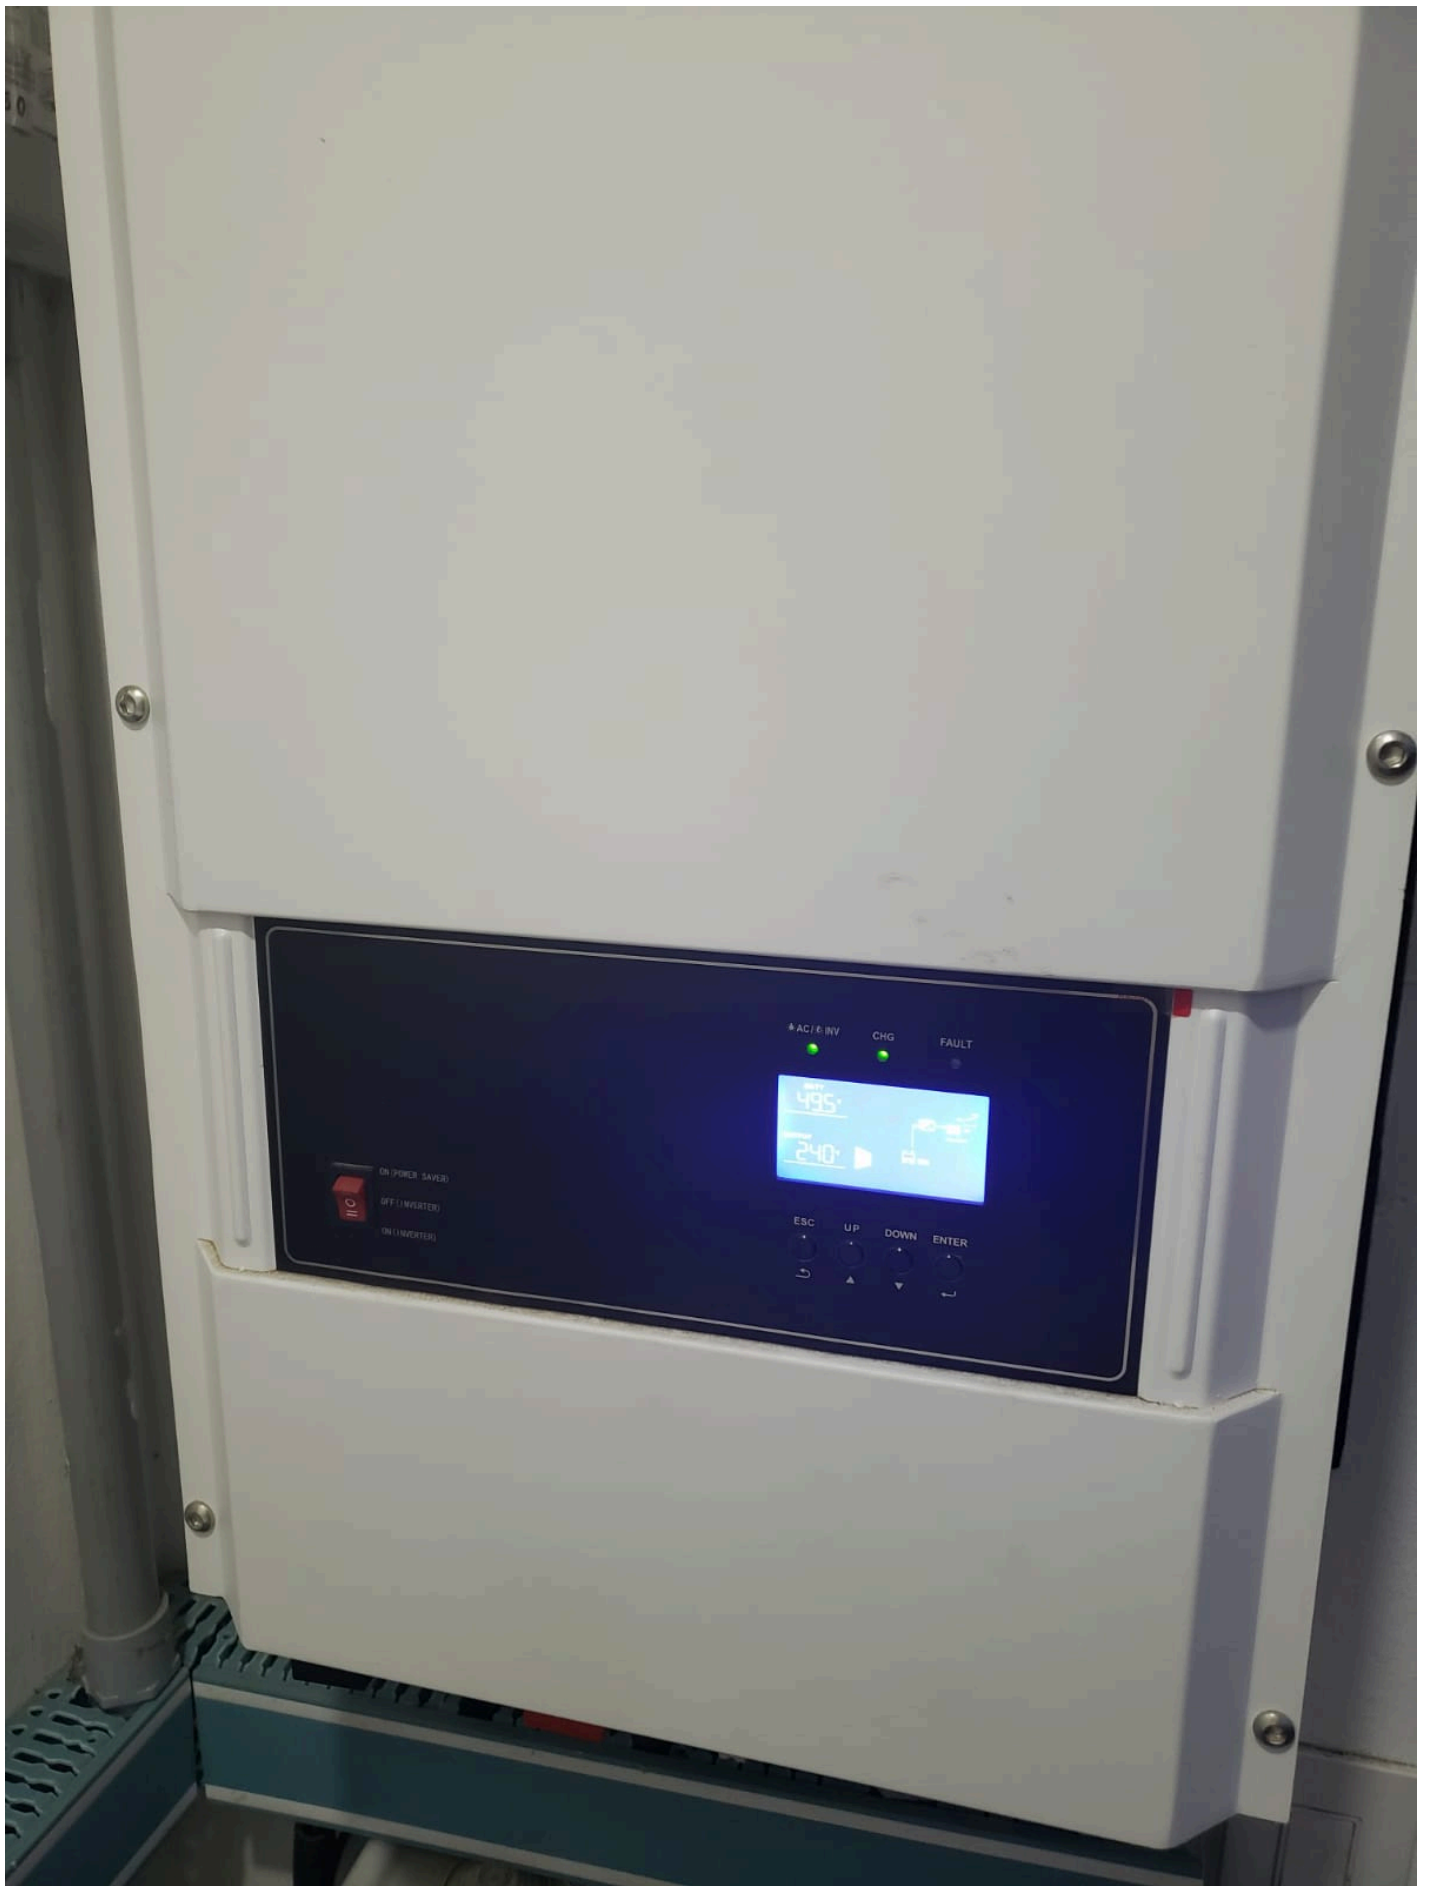
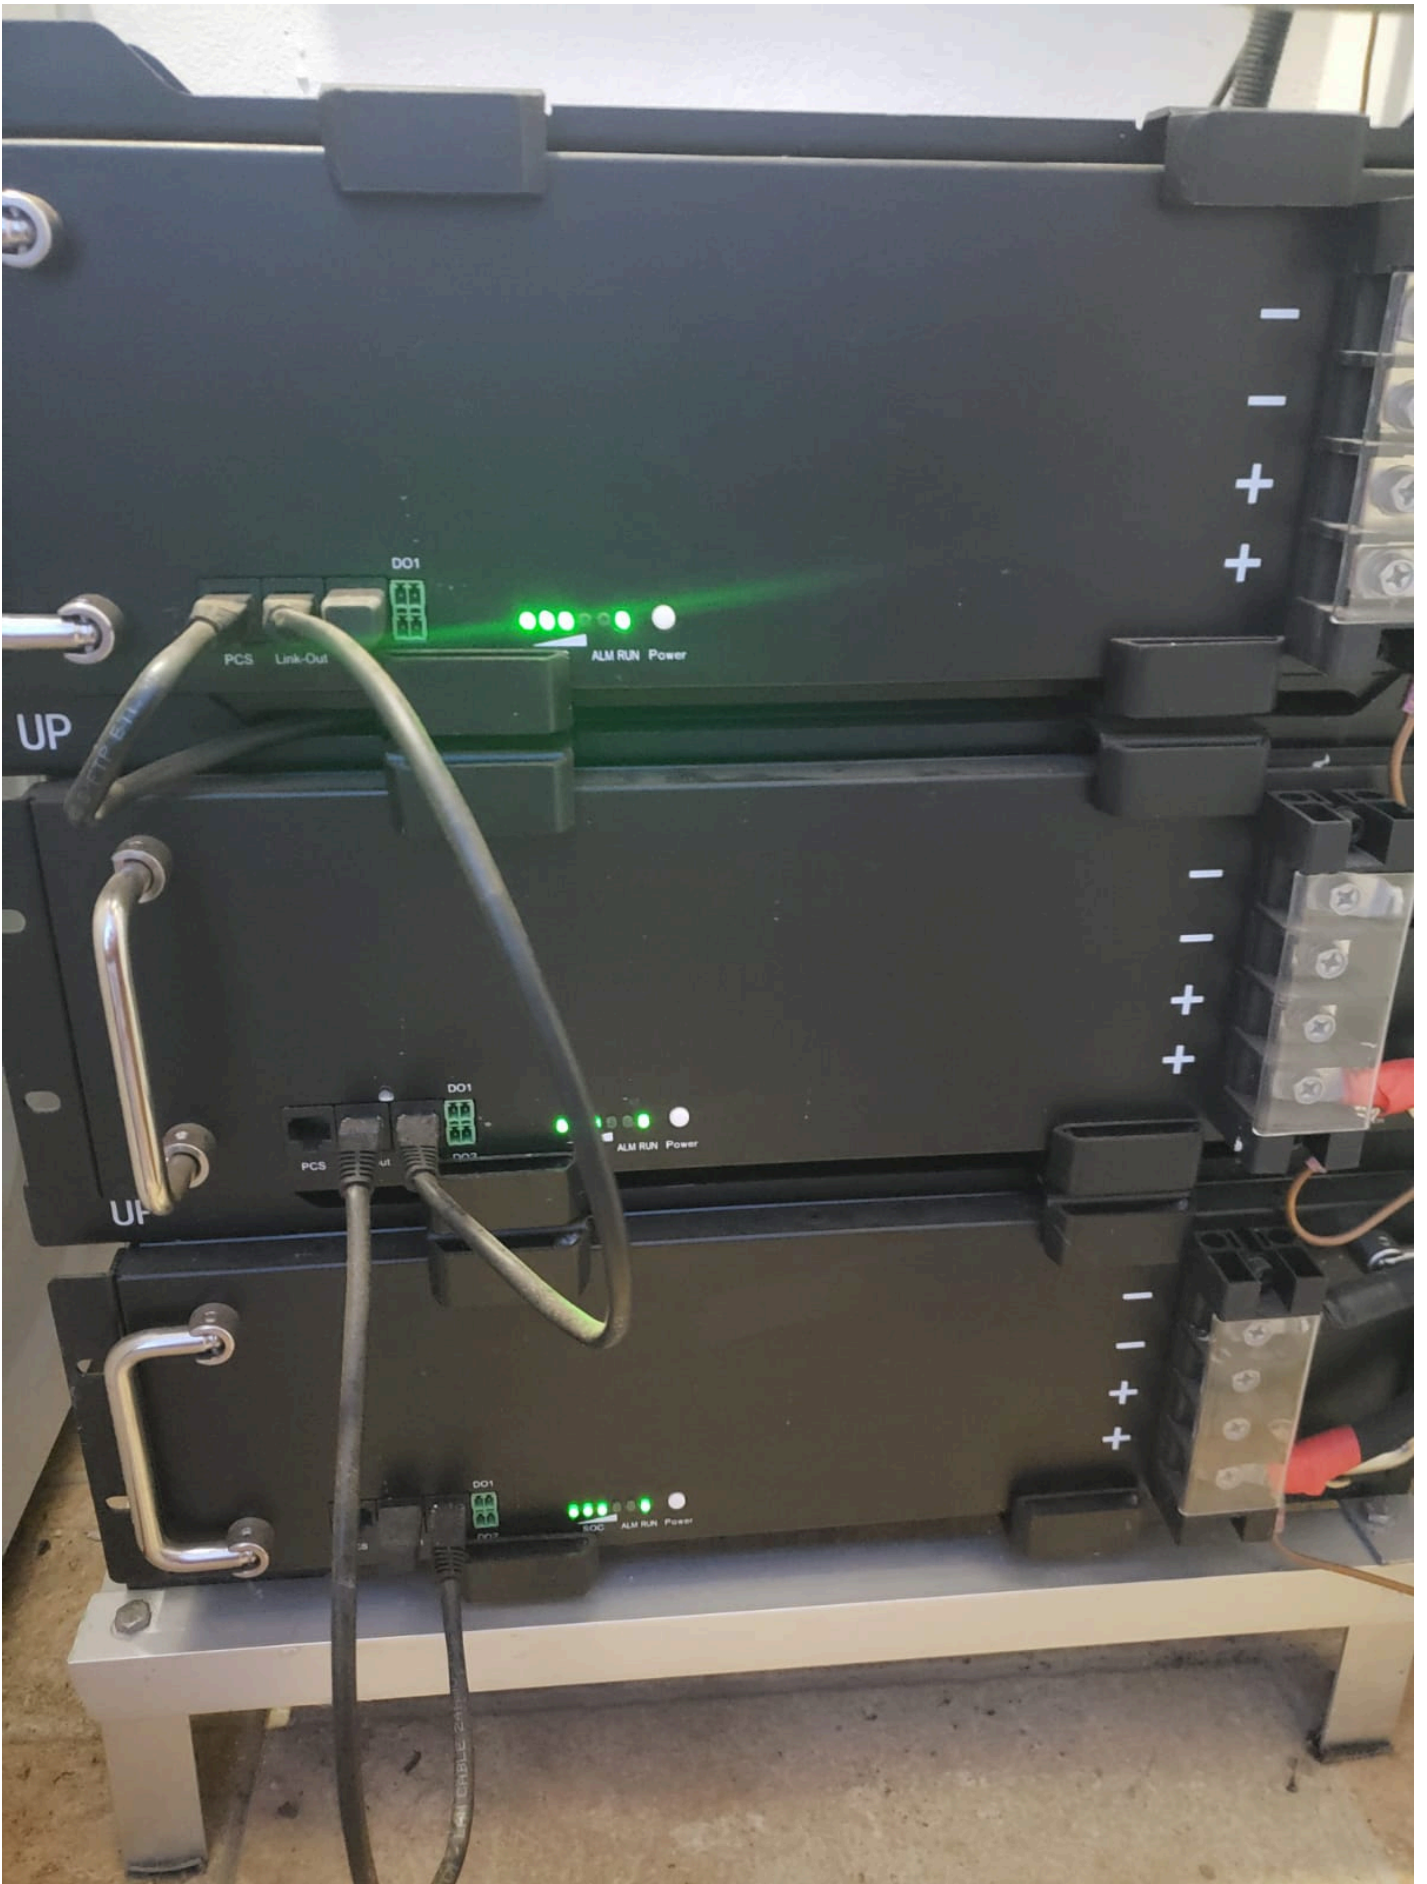
My system installation looks like this:

Today, Wednesday 31st of May, the system only charged the batteries to 60%. This is just one day of several on which the system is having problems. I had the system shutting down in the past several times. It is set to shut down at 9% battery level.

It seems like some systems at EVA are setup differently and are more efficient. Just my assumption. Maybe just my inverter is already using up all the battery power or some parts of the installation are not compatible. Maybe the aircon system is not suitable for the caravan type housing condition and size of solar system. It is very hot inside this locker area where the system is installed. Both the sun and the inverter keep heating up the inside to a level that is not suitable for a solar system. I only know installations where batteries, inverters, generators etc. are all installed in a special room, sealed area, well ventilated or air-conditioned, dust and dirt-proof and not together with a washing machine next to the batteries and a dodgy wooden flimsy door

to close the area and still all the construction dust, metal dust from around here is getting into the solar installation area. Also, my solar room is facing the sun most of the day. What will happen, when we have floods and the water penetrates the batteries. The batteries are very close to the ground. The houses up here Eva 55, 54, 53 etc are not so much at risk of major flooding, whilst other houses can easily see their systems flooded.

I can only ask you to look into this matter and find a solution.

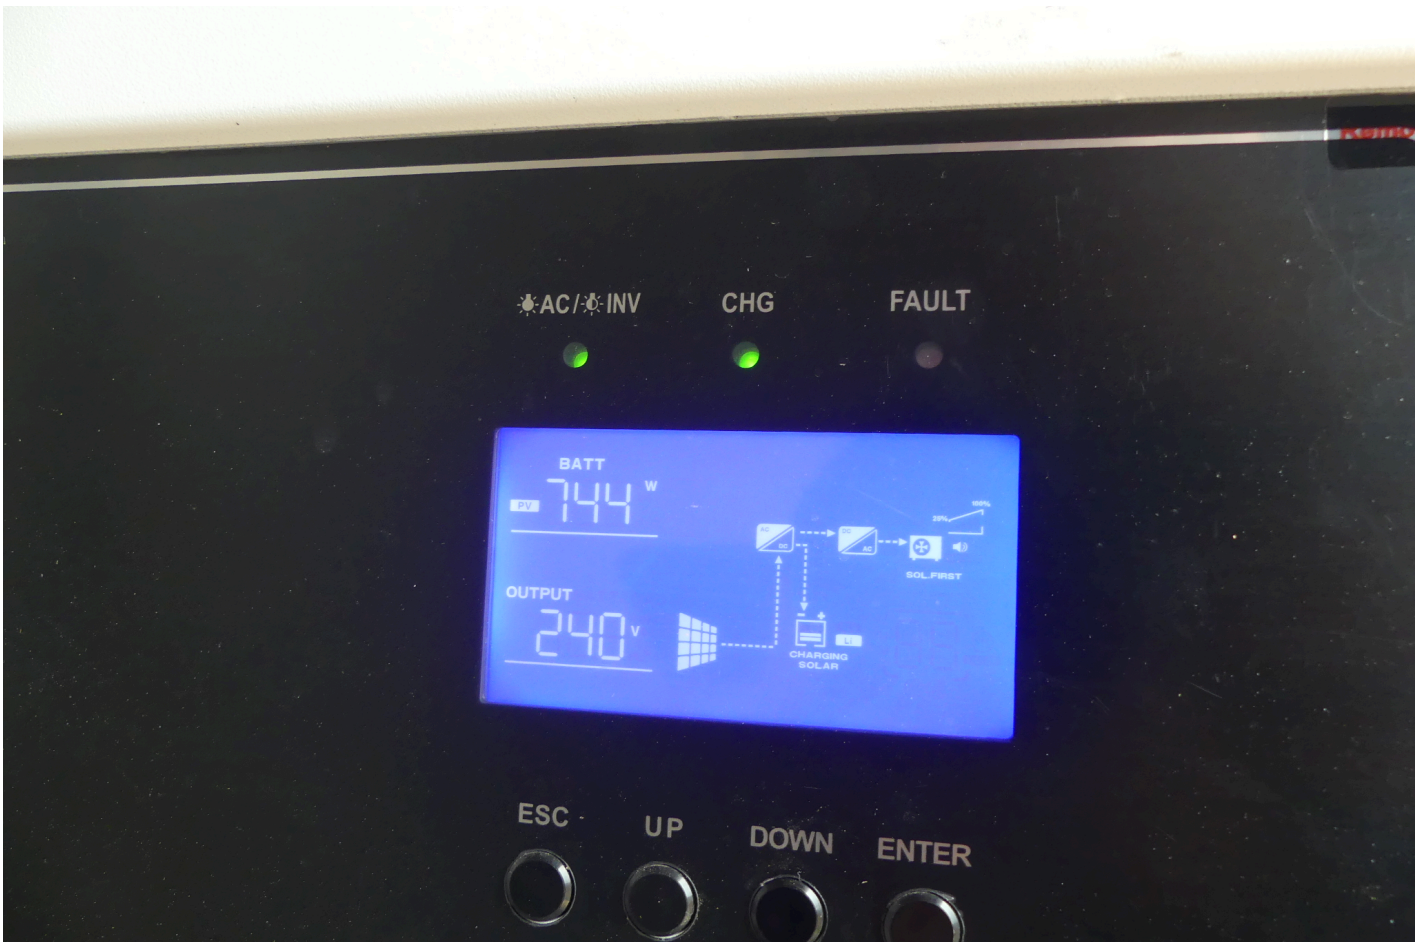
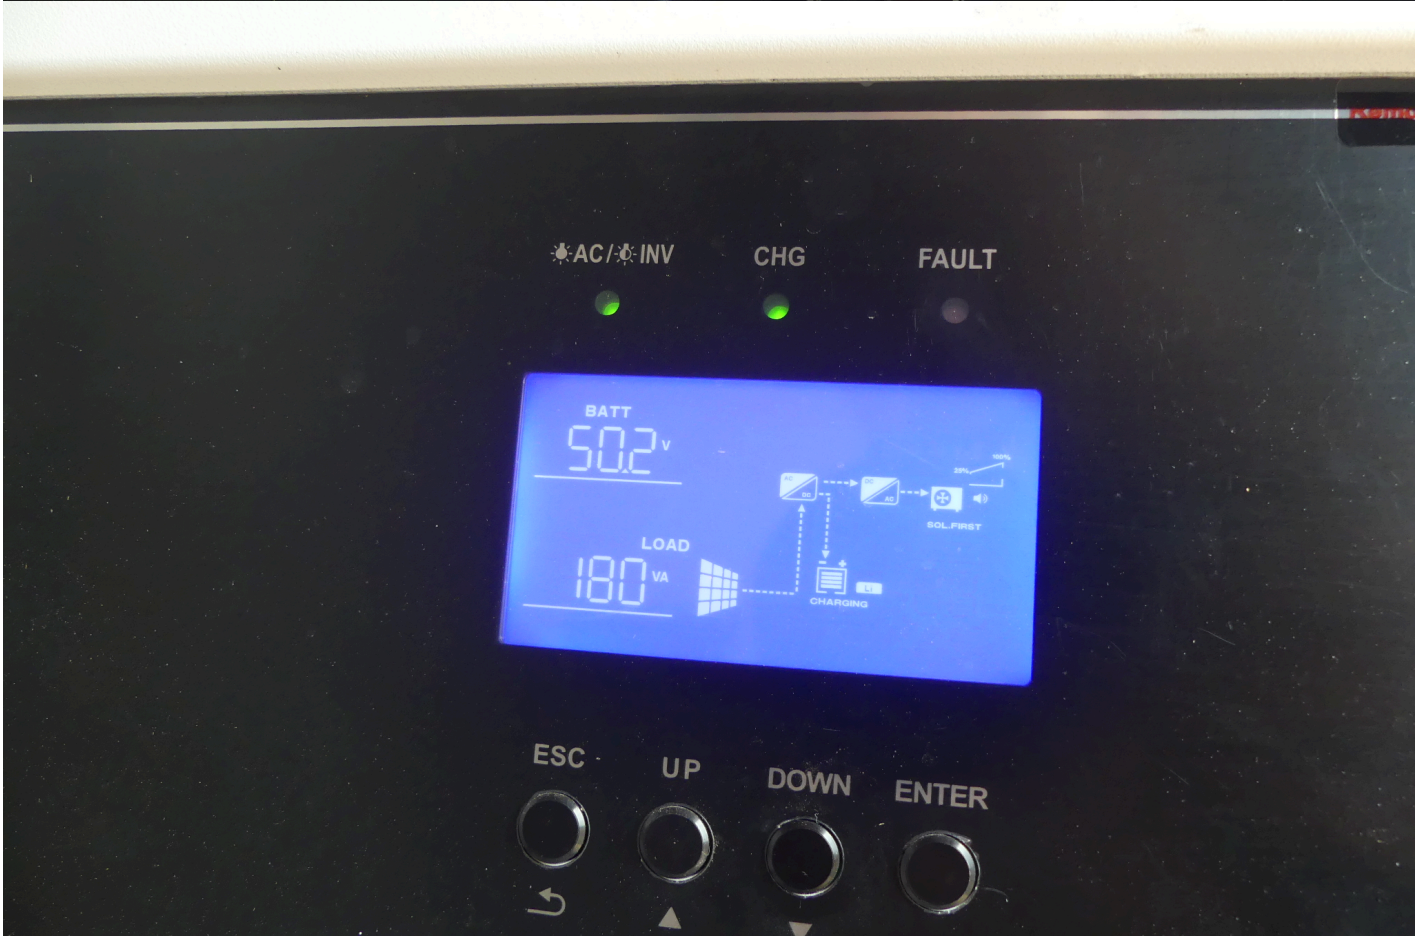
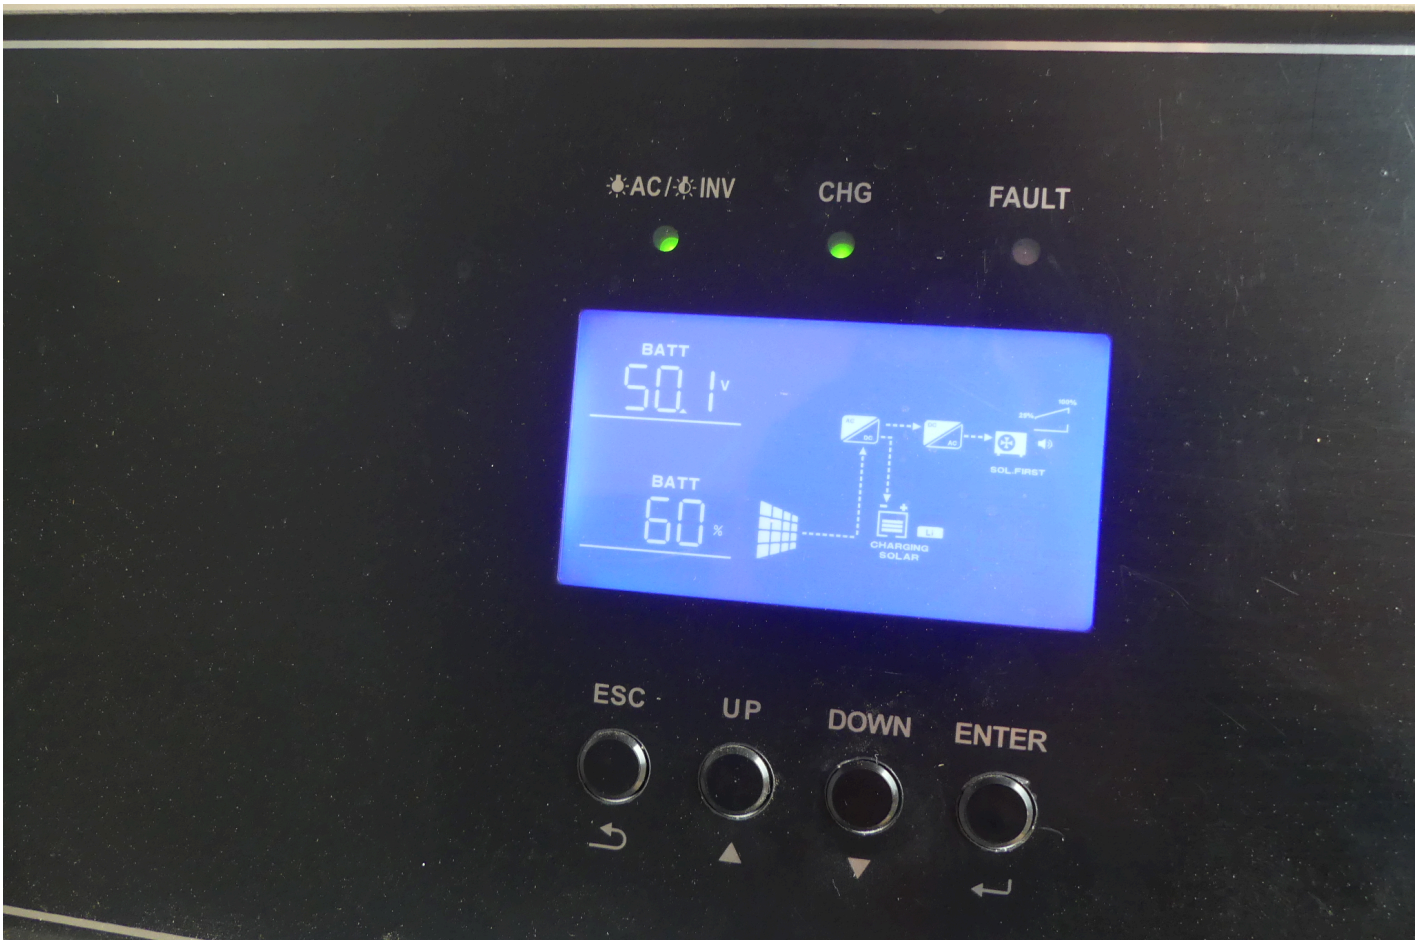
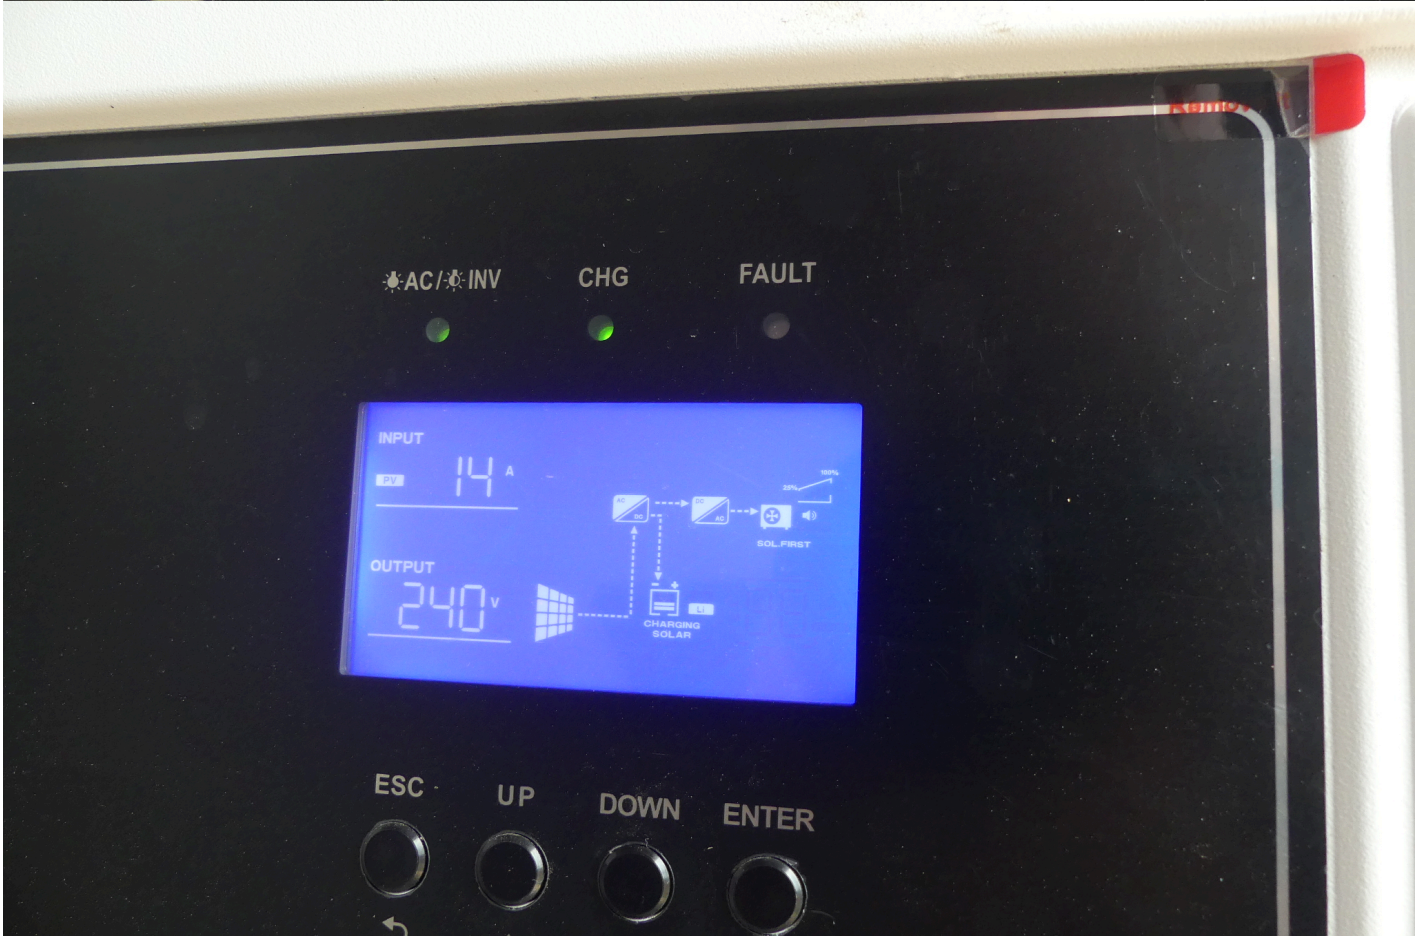
Readings today at 4pm after a full day's charge:

The system had discharged to around 24% by 6am today (the aircon upstairs had run all night at the lowest settings, the aircon in the bottom bedroom had been used on and off during the night at around 29 and 28 degrees celsius, i.e. lowest settings).

With the current weather conditions the system does not seem to be able to support the use of the aircon system. I can even foresee that if we have for example one week of bad weather, and as we all know, that is very likely to happen, that just by running the fridge my system will eventually shut down.
